DEPARTMENT OF TRANSPORTATION

Quality Assurance and Source Inspection

Contract #: 04-0120F4Cty: SF/ALA Rte: 80 PM: 13.2/13.9File #: 69.28**WELDING INSPECTION REPORT****Resident Engineer:**Siegenthaler, Peter**Address:** 333 Burma Road**City:** Oakland, CA 94607**Report No:** WIR-018296**Date Inspected:** 24-Nov-2010**Project Name:** SAS Superstructure**OSM Arrival Time:** 700**Prime Contractor:** American Bridge/Fluor Enterprises, a JV**OSM Departure Time:** 1900**Contractor:** Zhenhua Port Machinery Company, Ltd (ZPMC), Changxing Island **Location:** Shanghai, China**CWI Name:** Zhu Zhong Hai**CWI Present:** Yes No**Inspected CWI report:** Yes No N/A**Rod Oven in Use:** Yes No N/A**Electrode to specification:** Yes No N/A**Weld Procedures Followed:** Yes No N/A**Qualified Welders:** Yes No N/A**Verified Joint Fit-up:** Yes No N/A**Approved Drawings:** Yes No N/A**Approved WPS:** Yes No N/A**Delayed / Cancelled:** Yes No N/A**Bridge No:** 34-0006**Component:** Orthotropic Box Girder(OBG)**Summary of Items Observed:**

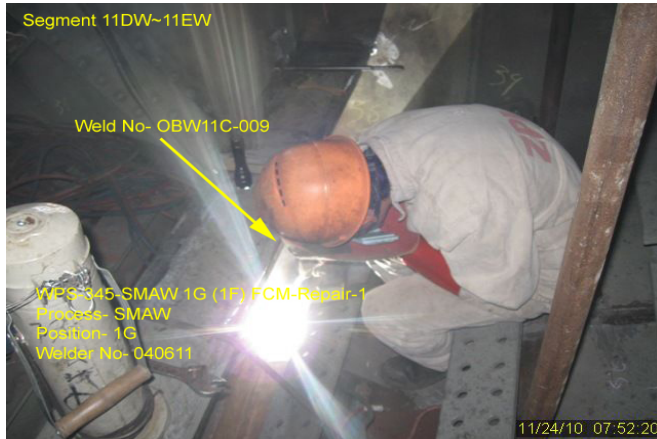
WELDING:**Segment 11DW ~ 11EW**

This QA Inspector observed ZPMC qualified welding personnel identified as 040611 perform Shielded Metal Arc Welding (SMAW), weld joint identified as OBW11C-009; located On Orthotropic Box Girder (OBG) Side Plate to Side Plate Transverse Splice Weld; The Critical Welding Repair Report (CWRR) was B-CWR2269. ZPMC Quality Control (QC) is identified as Mr. Shi Lei. The welding variables recorded by QC appeared to comply with applicable WPS-345-SMAW 1G (1F) FCM-Repair-1. See attached photo for further details.

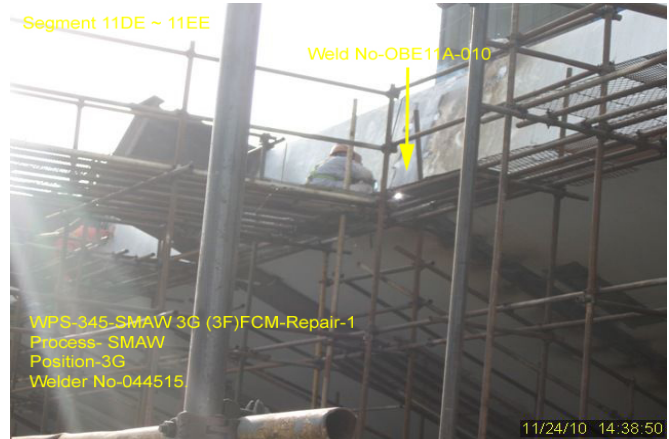
Segment 11DE ~ 11EE

This QA Inspector observed ZPMC qualified welding personnel identified as 044515 perform Shielded Metal Arc Welding (SMAW), weld joint identified as OBE11A-010; located On Orthotropic Box Girder (OBG) Edge Plate

to Edge Plate Transverse Splice Weld; The Welding Repair Report (WRR) was B-WR17689. ZPMC Quality Control (QC) is identified as Mr. Wang Li Yang. The welding variables recorded by QC appeared to comply with applicable WPS-345-SMAW 1G (1F) FCM-Repair-1. See attached photo for further details.
